Repair of Partially Penetrated Weld Joints in Copper-Nickel Seawater Piping on Naval Ships

Master of Science in Naval Architecture and Marine Engineering and
Master of Science in Materials Science and Engineering

Massachusetts Institute of Technology

September 2000

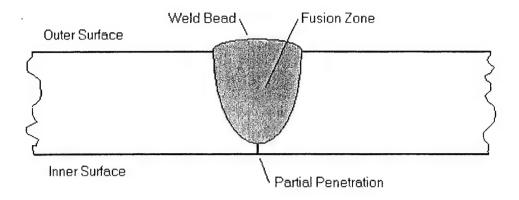
Figure 1-1: Schematic of a Partially Penetrated Weld Joint

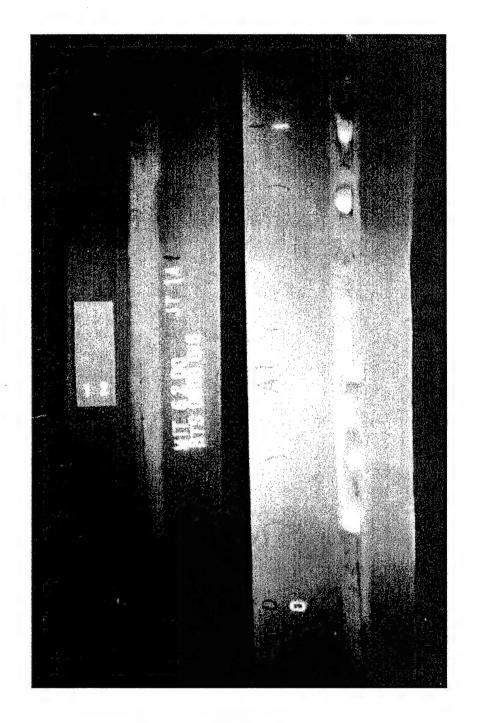
Figure 4-1: Weld A1, Section 0-1

Table 4.4 indicates that all the welds in the A-series pipes were unsatisfactory. Since these are the welds that most closely reflect the practical situation, this result would seem a conclusive condemnation of weld repair without cleaning the root surface. However, it actually shows the practical difficulty of performing this sort of repair. Examination of the X-rays in Figures 4-1 through 4-12 alongside the pipes themselves shows that whenever the repair weld lay on top of the flawed weld, and fully penetrated the pipe wall, the resultant weld is whole and not flawed. It was difficult to obtain this, however. Small misalignment was sufficient for the repair weld to miss the seam. Obtaining full penetration without burning through was a delicate matter, especially when starting the weld. Most of the incomplete penetrations are at starting points before the welder obtained full penetration. This is another facet that depends

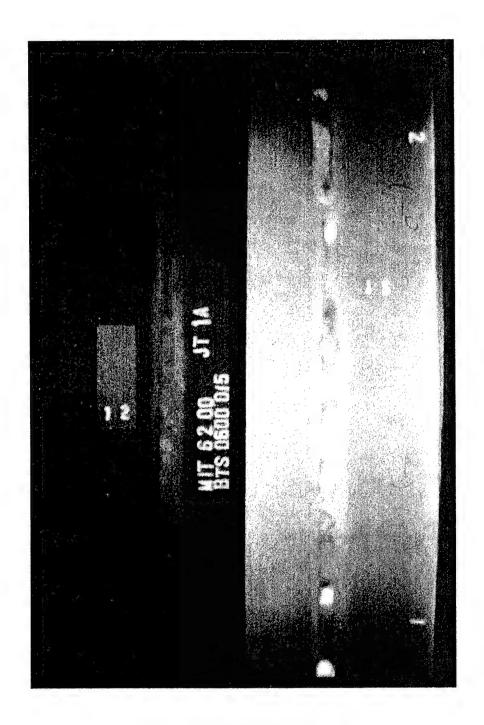
Figure 4-2: Weld A1, Section 1-2

Weld No.	Accept	Reject	Defect Codes
A1		X	IP
A2		X	IP
A3		X	IP
A4		X	IP, P
C1	X		
C2-A	X		
C2-B	X		
С3-А	X		
С3-В	X		
C3-C	X		
C4-A	X		P
C4-B	X		LI
C5-A		X	P
C5-B	X		P
C5-C		X	P
C5-D	X		
C5-E		X	P
C6-A		X	IP, P, CV
C6-C		X	IP, P
C6-D		X	IP, P
C7-A	X		
С7-В	X		
C7-C	X		P
C8-A	X		
C8-B	X		
C8-C	X

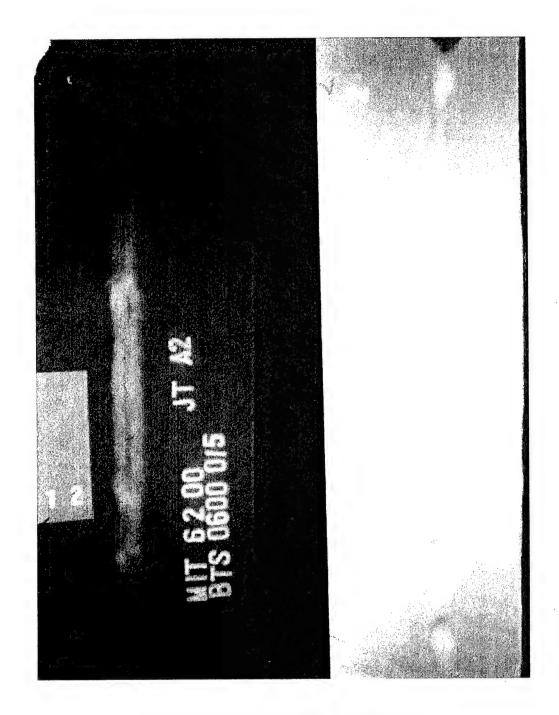
Figure 4-21: Close-up of Weld A2, Section 1-2

on the individual welder's proficiency. Figures 4-21 through 4-24 show close-ups of the X-rays showing locations where the repair weld did indeed fill the flawed weld. Figures 4-25 through 4-27 are photographs of the root surface of effectively repaired welds, cleaned of scale. The black lines show where the partial penetration had been; the arrows indicate the extent of the full penetration. The protruding bead has filled the crevice.

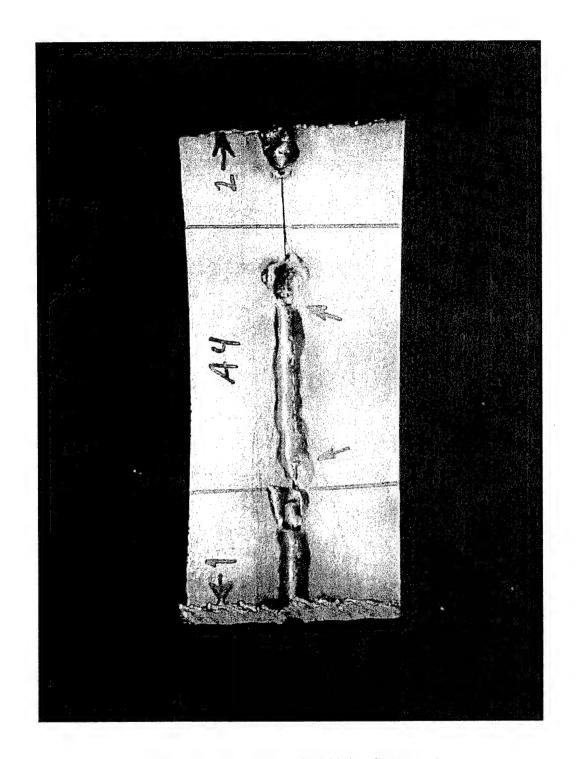
Figure 4-27: Root Face of Weld A4, Section 1-2

and calcium in the base metal is probably due to incomplete cleaning of the surface. Weld A4 shows more variation, in particular more oxygen in the weld bead, but still not significantly different. Welds C4-A and C4-B show almost no variation. Welds C6-A, C6-C and C6-D show little variation between the bead and the base metal. The most variation is in the oxygen content and manganese in weld C6-A. These results indicate that welding from a clean outside surface through an uncleaned root face does not increase the likelihood of absorbing the internal scale into the weld metal.

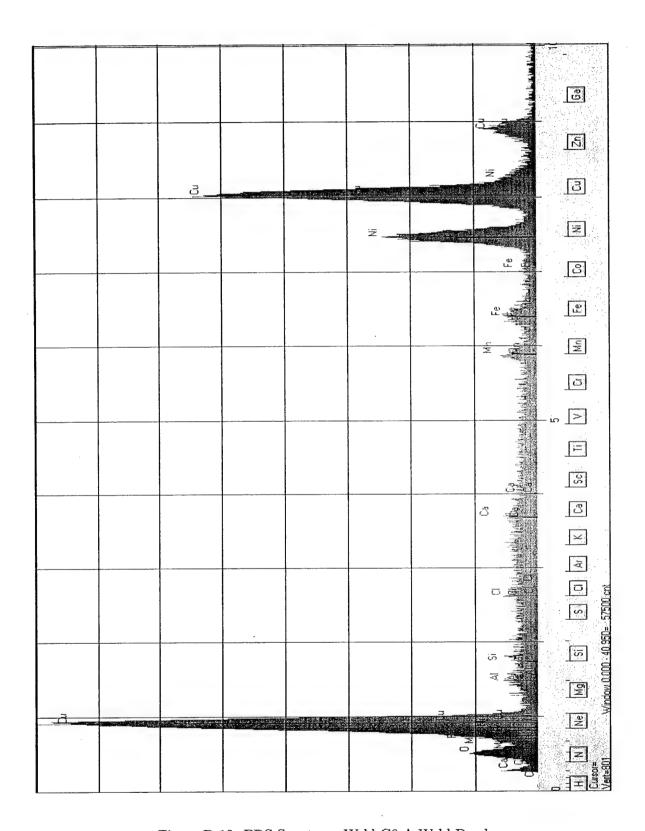
Figure D-9: EDS Spectrum Weld C6-A Base Metal

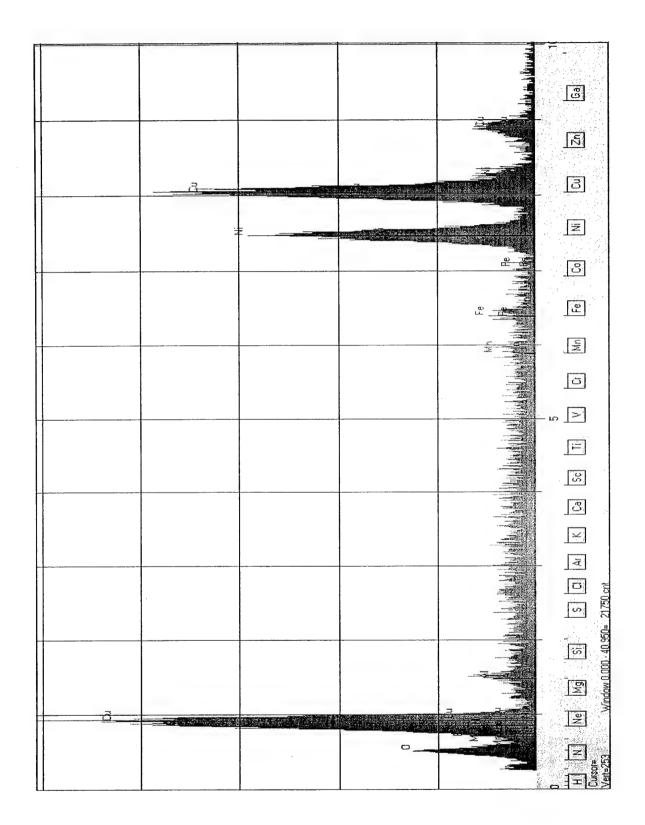
Figure D-10: EDS Spectrum Weld C6-A Weld Bead

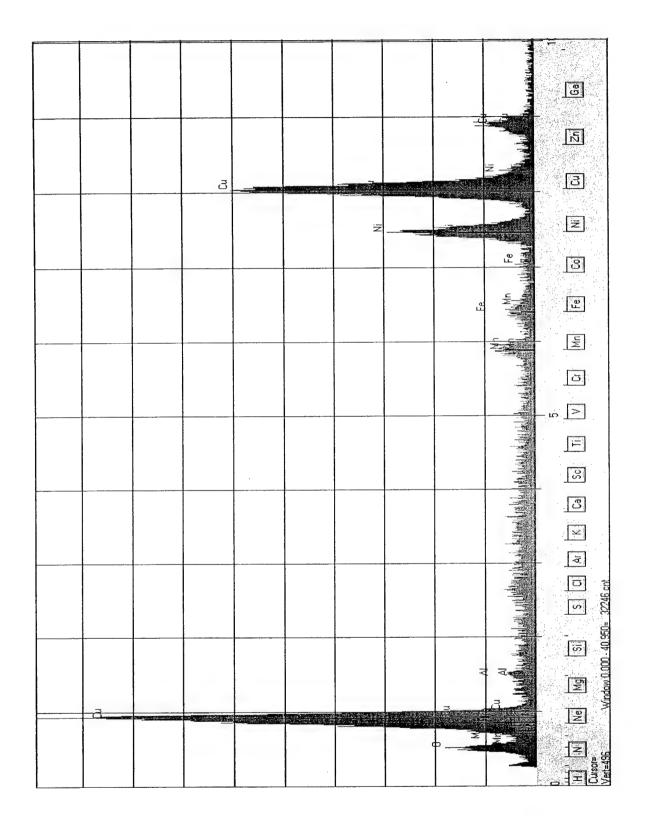
Figure D-11: EDS Spectrum Weld C6-C Base Metal

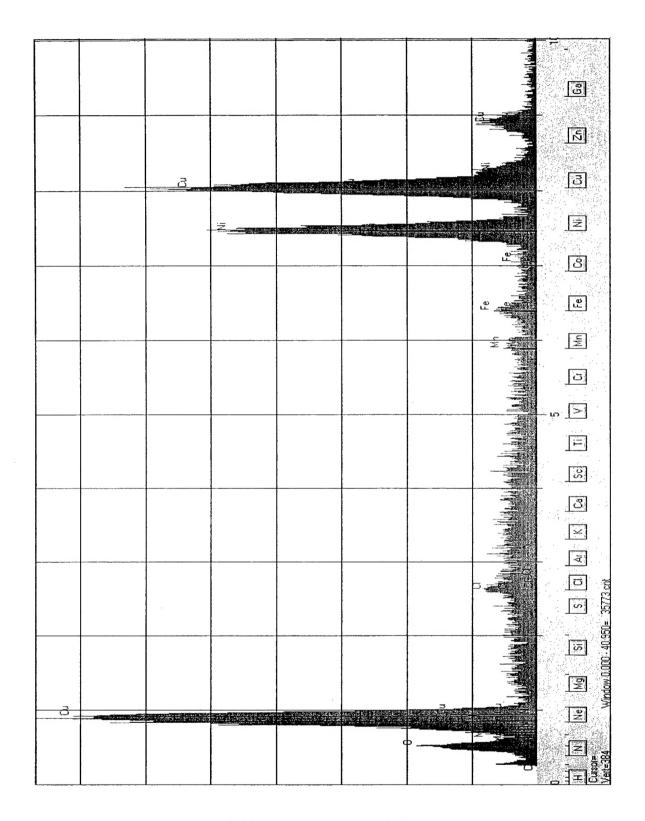
Figure D-12: EDS Spectrum Weld C6-C Weld Bead
